[Docket No. 96-NM-75-AD; Amendment 39-9581; AD 96-09-07]

Airworthiness Directives; Boeing Model 757 Series Airplanes Equipped with Moog Spoiler Actuators

96-09-07 BOEING: Amendment 39-9581. Docket 96-NM-75-AD. Supersedes AD 96-06-01, Amendment 39-9537.

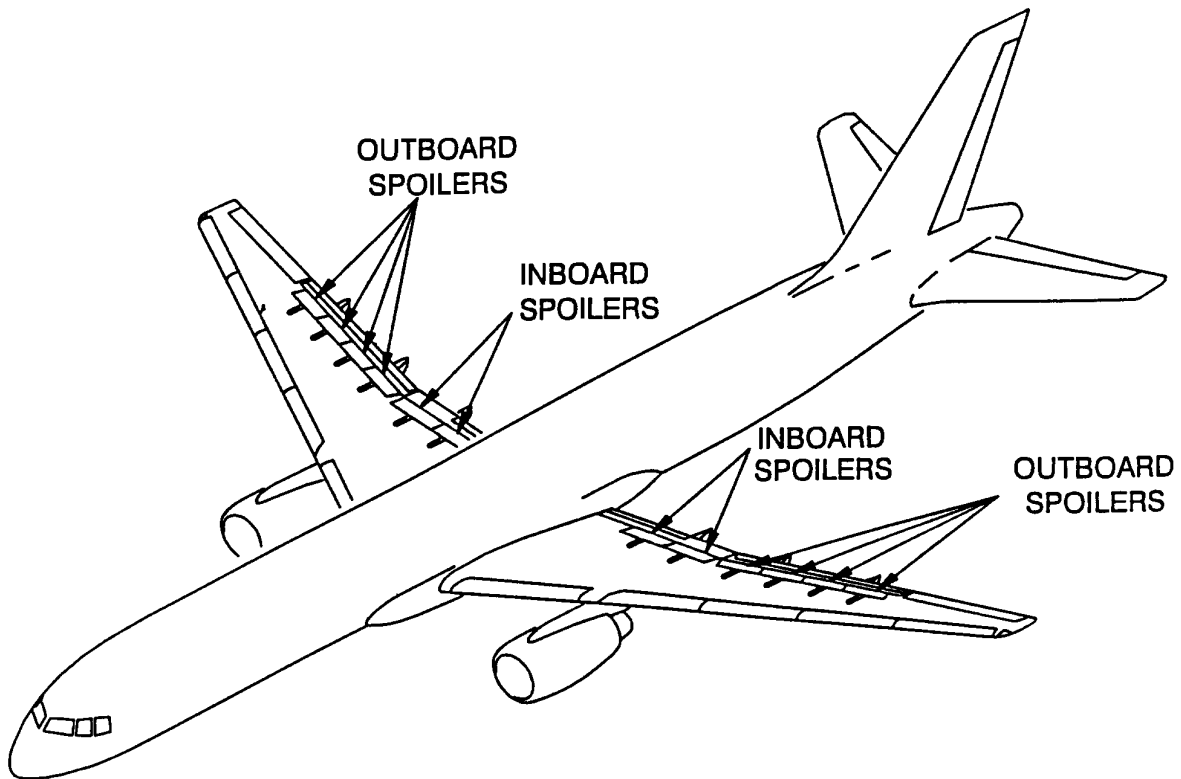
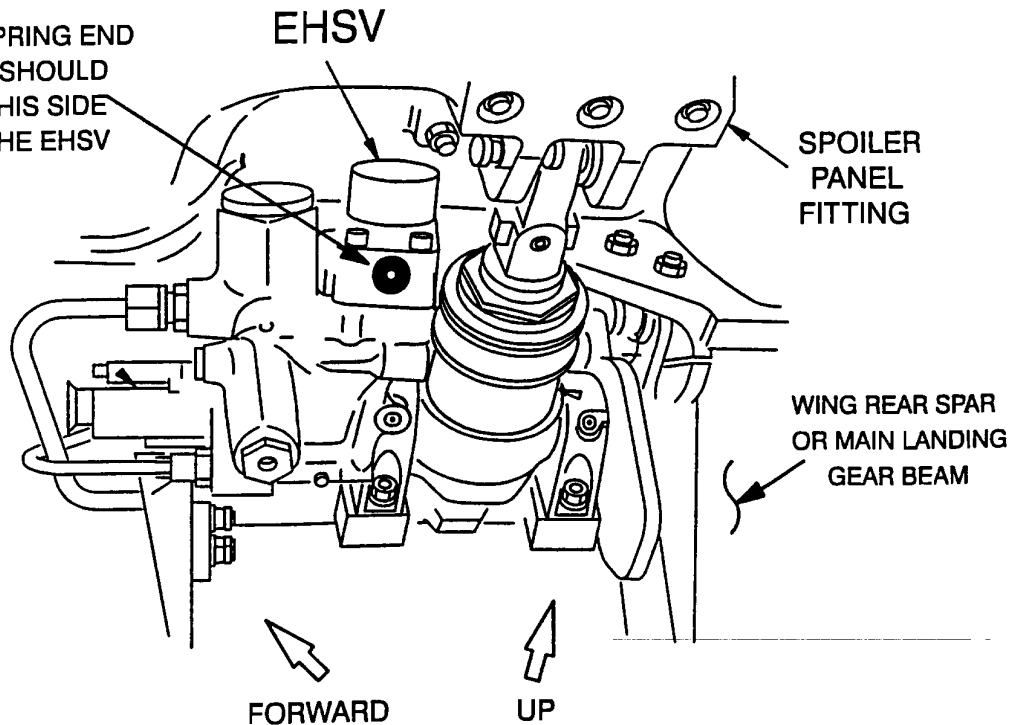
APPENDIX 1

(1) While the airplane is on the ground, extend the flaps to 40 degrees and visually inspect the spoiler actuator EHSV assembly to determine the location of the second stage bias spring end cap assembly.

NOTE 2: To be correctly positioned, the second stage bias spring cap assembly should be on the upper or forward side of the EHSV assembly. Appendix 1 of this AD provides a visual representation of the correct positioning of the EHSV assembly.

SECOND STAGE SPRING END
CAP PROTRUSION SHOULD
NOT EXTEND ON THIS SIDE
(UNDERSIDE) OF THE EHSV

(2) If the second stage bias spring cap assembly is on the aft or lower side of the EHSV assembly, prior to further flight, replace the EHSV, having Abex part number 72196, with a serviceable unit in accordance with the airplane maintenance manual.
